Asia Pacific Regional Marine Forum – Tokyo June 2018

Mooring Equipment Guidelines (MEG) publication update

ZARGA Mooring Accident LESSONS LEARNED

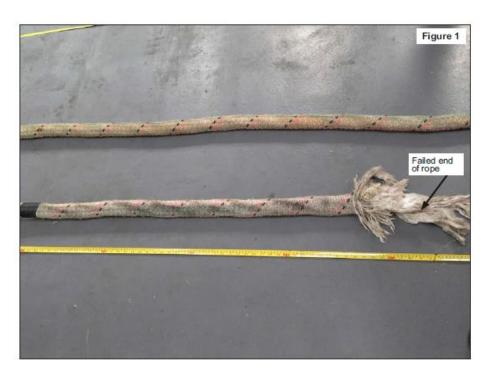
Mooring Line:

MBL = 137 tonnes failed at 24 tonnes Life expectancy = 8 years failed at 5 years

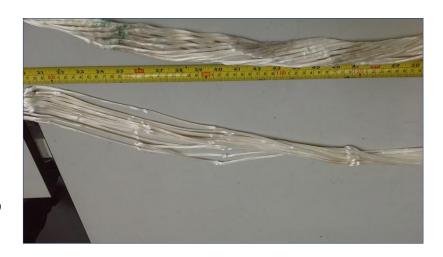
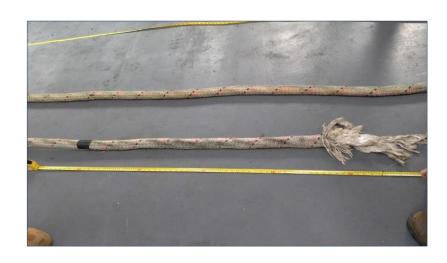
Failure of HMSF fibre mooring line

- Loss of strength over time due to kink bands created by axial compression
 - Minimum breaking load of the line was 137 tons, failed at 24 tons
- Service related causes of axial compression include: twisting of the line, bending around improperly sized deck fittings, and cyclic loading.
- Jacketed core prevented detection of damaged fibers
- Snap back underestimated

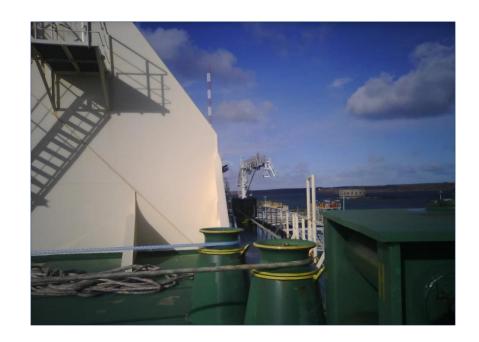
Incorrect size of deck fittings

- Manufacturer's guidance stated the ratio of the diameter of the deck fittings to the diameter of the mooring line (D/d) was critical
- Minimum recommended D/d of 12:1 for lines on board ZARGA
 - Pedestal roller D/d = 10.22
 - Roller fairlead D/d = 9.1
- Factors related to mooring lines not taken into account when fittings were selected by the builder

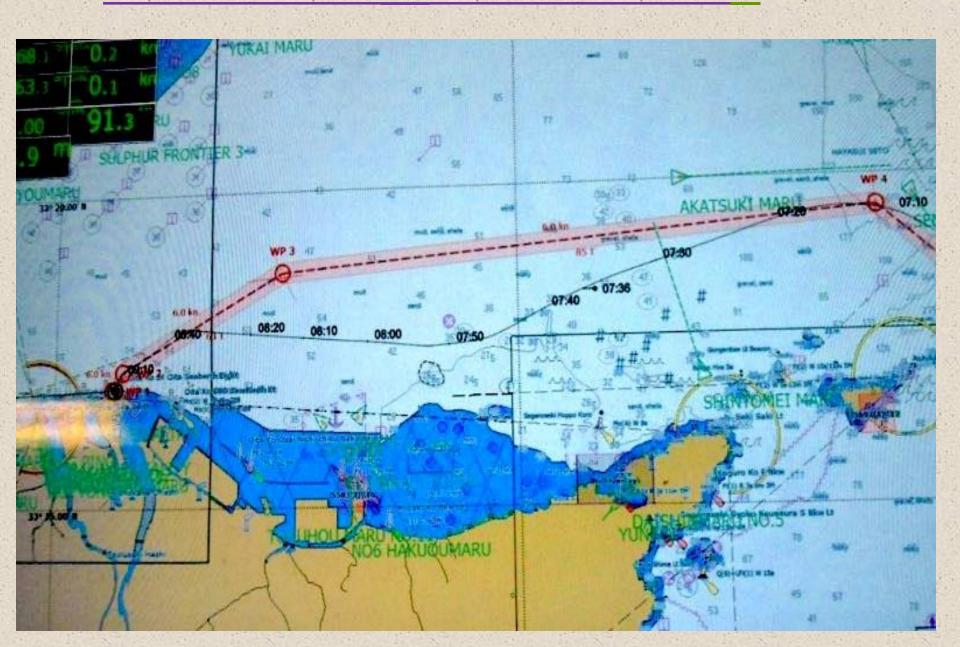
INCIDENT — ECDIS SCREEN

Of planned passage & actual passage showing the substantial deviation taken to avoid heavy fishing traffic.
