Lifeboat Incident Survey - 2000

*Results from a Joint Industry Survey carried out
by
OCIMF, INTERTANKO AND SIGTTO*

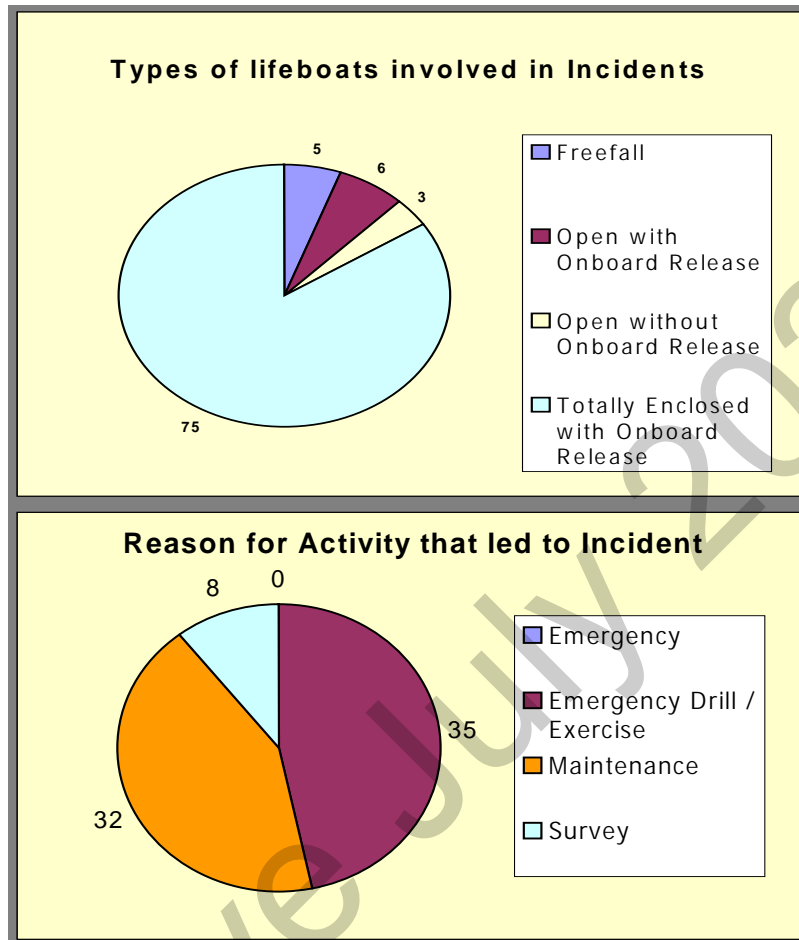
The charts below show the proportions of different lifeboat types involved in the reported incidents.

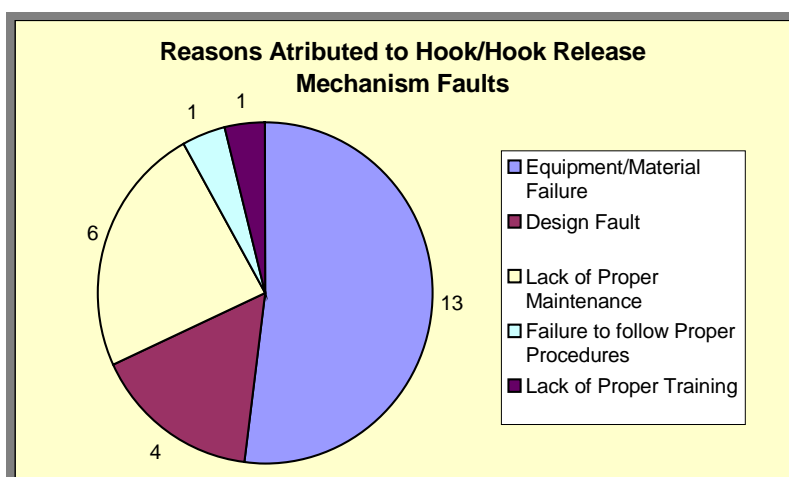
Hook/Hook Quick Release Mechanisms

As previously noted, incidents attributed to faults with the Hook/Hook release Mechanism are the greatest single group. Of these 25 incidents, over 50% are due to failure of the equipment or of the material. When

Design Fault is added some 68% of these incidents can then be grouped as a single "Design factor". If at the design stage the requirement for non-critical maintenance was addressed, the incidents categorised under Lack of Proper Maintenance may not have occurred. Therefore, all but 2 of these incidents can be attributed to poor design of the Hook/Hook Release Mechanism.
